TECHNICAL REPORT SL-86-6

DYNAMIC TEST OF A CORRUGATED STEEL KEYWORKER BLAST SHELTER

Stanley C. Woodson, Thomas R. Slawson,
and Randy L. Holmes

Final Report
May 1986

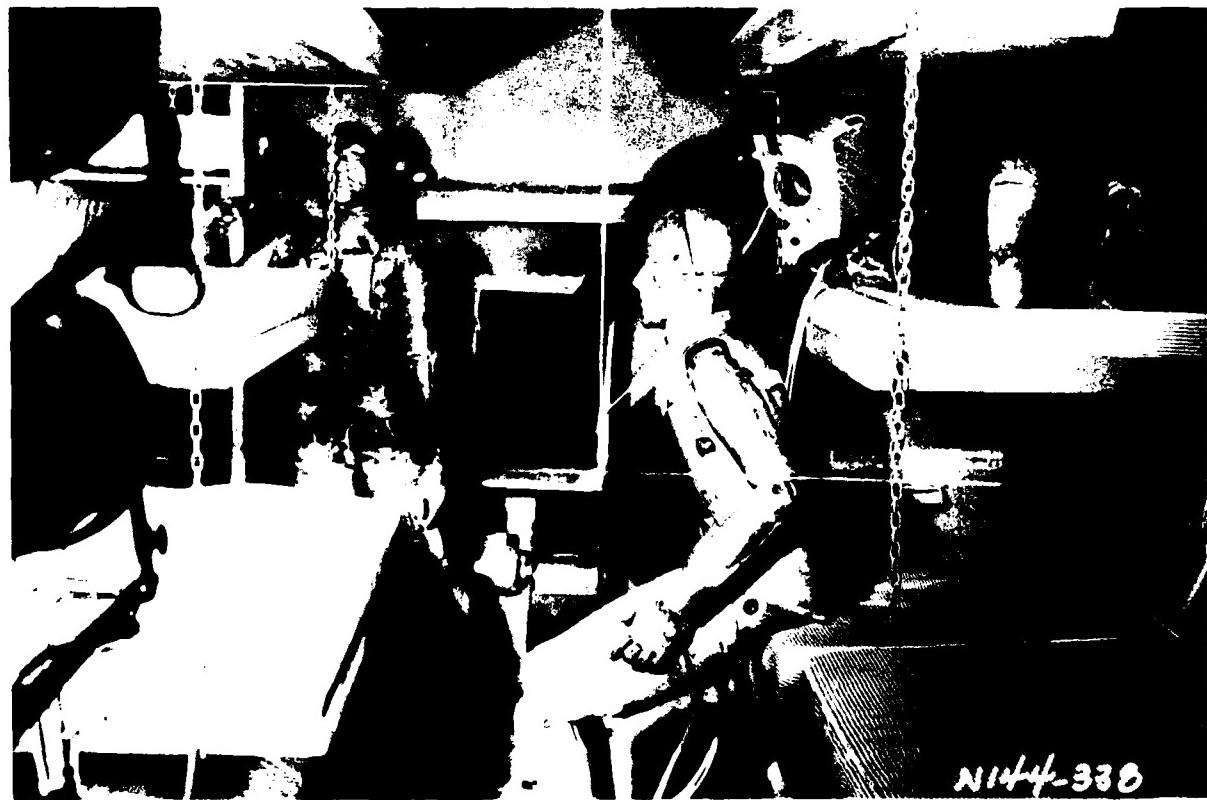
a. Pretest positions.

b. Posttest positions.

Figure 3.3. Mannequins inside shelter.

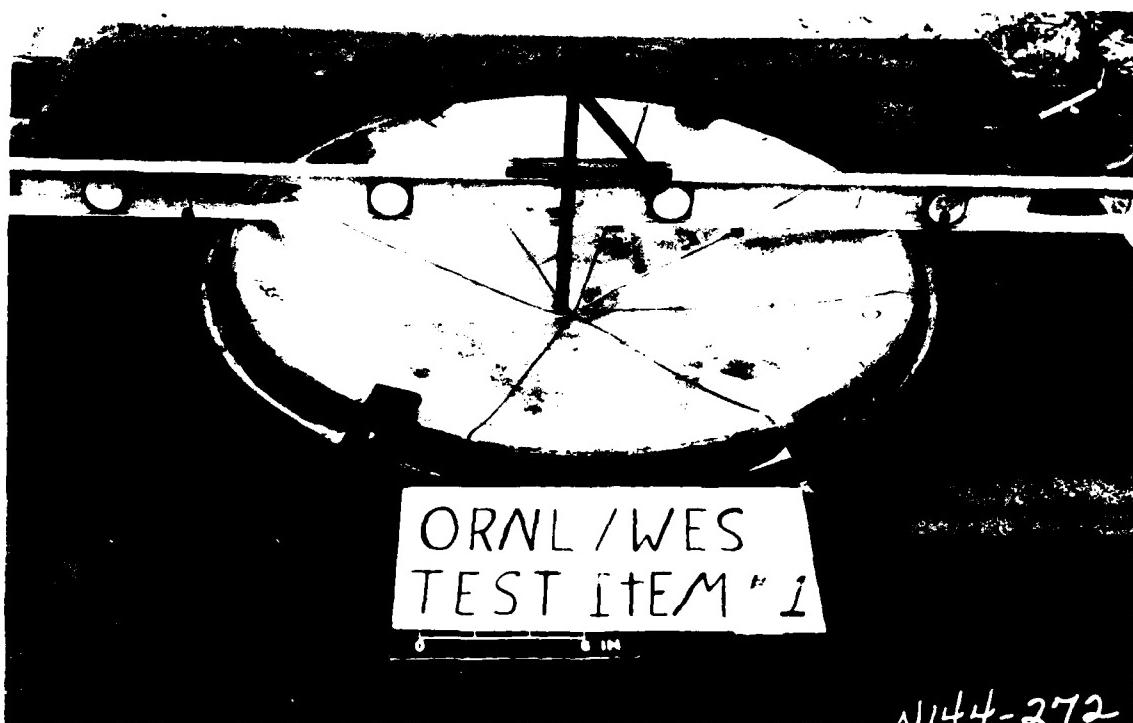
None of the closures ruptured. The "yielding membrane" design (1/8-inch-thick carbon steel) is adequate for withstanding the 50-psi peak overpressure level from a 1-MT nuclear weapon. The tests showed that the use of a 60-inch-diameter culvert skirt beneath the closure is not necessary. The yielding membrane design is recommended for the galvanized steel Keyworker blast shelter.

Figure D.12. Posttest view of Item 1.

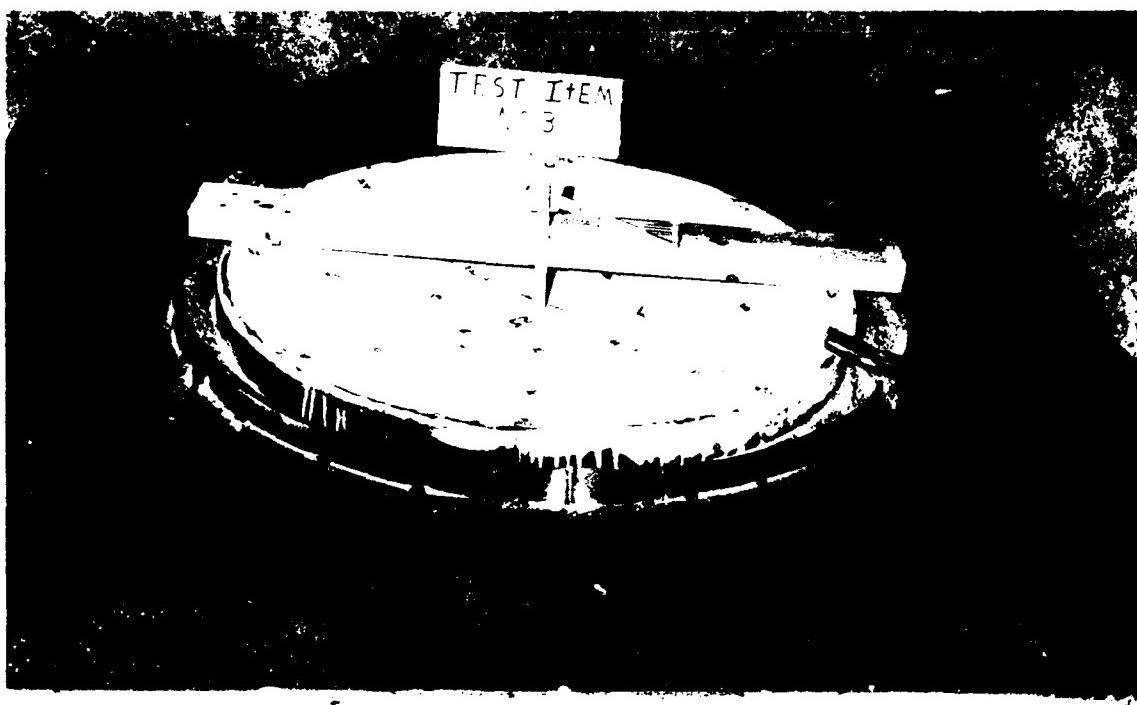
Figure D.14. Posttest view of Item 3.
